## Gold Quarry Slide – Investigation Project Status Report 25Apr05

### CAUSAL INVESTIGATION

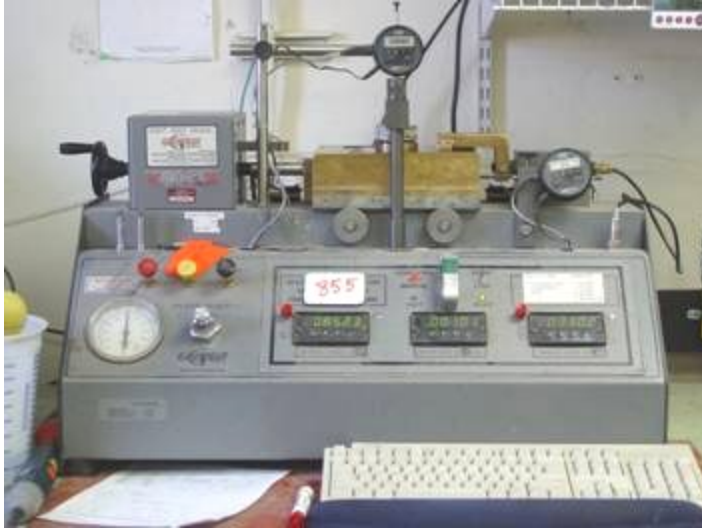
*Collected material samples from all boreholes are at CNI's laboratories in Tucson, AZ and testing, under the supervision of Ross Barkley, is in progress. Shear testing of an individual sample is taking 8 or more hours (Figures 1 and 2). Additional characterization tests, as per the program (Memorandum Table 1), are also underway. In accordance with the testing program, samples from Lift 1 will be selected and sent to Dr. Mesri at the University of Illinois for ring shear tests.*

**Figure 1.** *Small-scale direct shear test machine at Call & Nicholas' laboratory.*

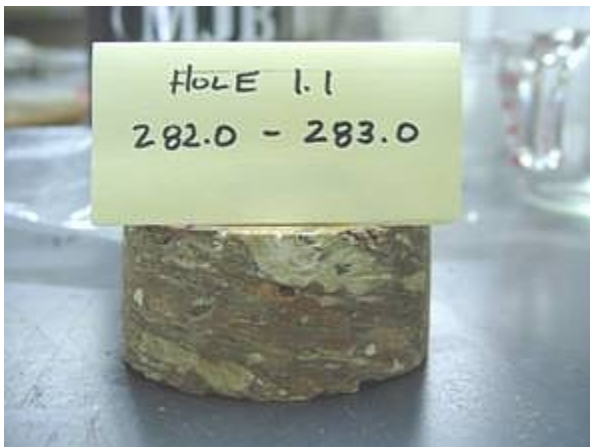
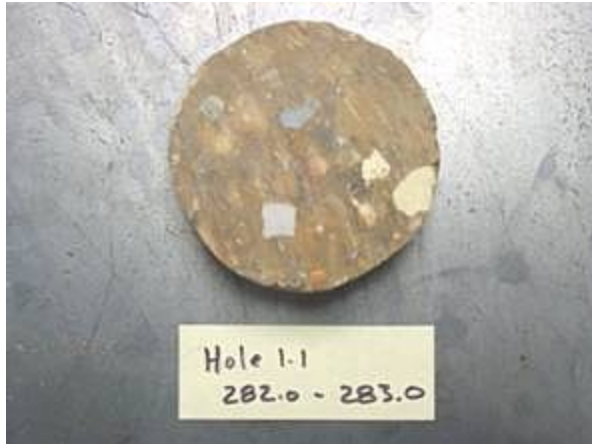
**Figure 2.** Material sample prepared for shear testing.

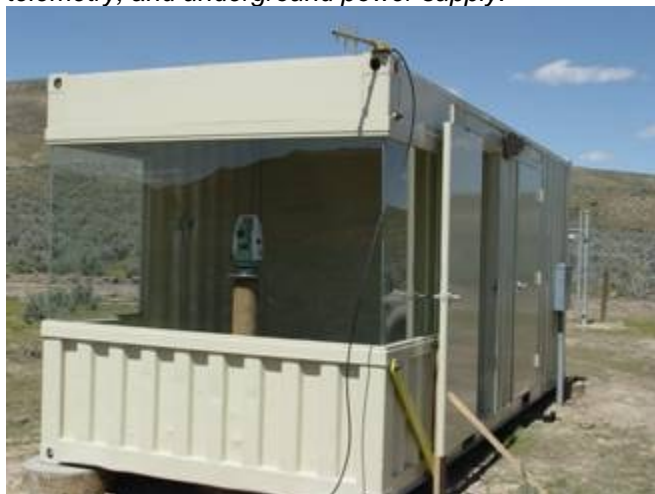
- ⊕ Geotechnical Monitoring: *The robotic theodolite and associated equipment has been installed and is operational. Slope movement monitoring, with cable extensometers and automated surveys of prisms, is continuing. In general, there appear to be no significant changes in movement rates; movement - if any - at most prisms is very slow. However, over the past few days there has been a slight increase in the movement rates of some of the prisms. This is under investigation but may be due to 1) some overbank material from the unweighting was pushed into the main failure mass; 2) the cleanup work at the toe; or 3) precipitation during the wet weather over the past few days.*

**Figure 3.** Robotic theodolite and enclosure. Note pedestal-mounted theodolite, antenna for data telemetry, and underground power supply.

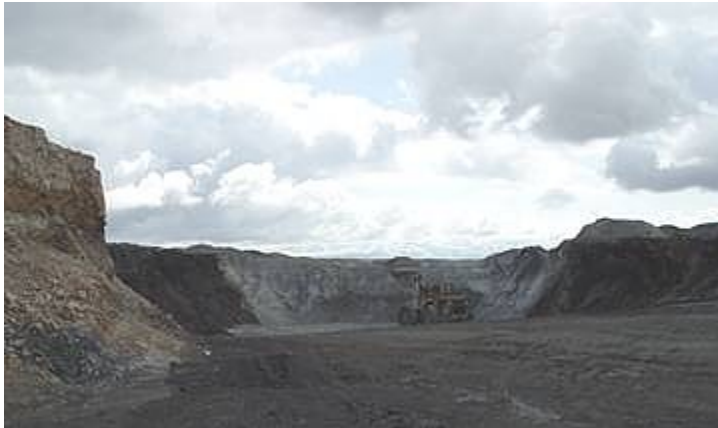
- ⊕ Unweighting: The initial unweighting excavation work was completed on 17Mar with about 900,000 tons of material removed from the top of the waste rock facility. About 800,000 tons have been removed in the second phase of unweighting with approximately 200,000 tons more to be removed over the next several days.

**Figure 4.** Unweighting cut – Phase 2.

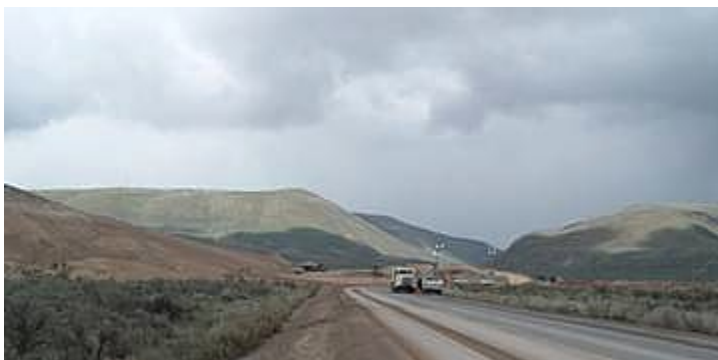
- ⊕ Road Excavation: Road excavation recommenced after the initial unweighting work was completed and was conducted 'in balance' with the second phase of unweighting. Excavation of road corridor has been completed and only a 5-foot layer of slide material remains on the pavement (Figures 5, 6, and 7). Slide toe area contouring to a 3.5:1 slope continues.

**Figure 5.** Road excavation – view looking 'north' on SR766.

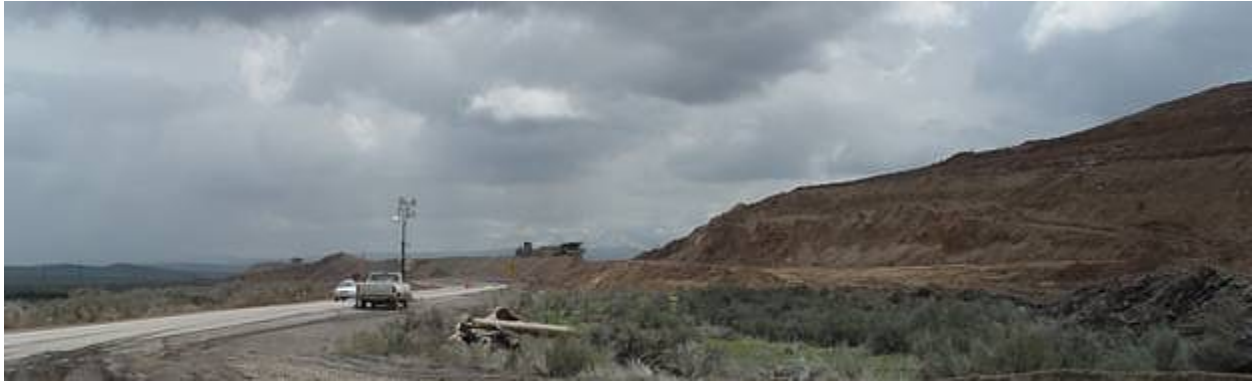
**Figure 6.** Road excavation – view looking ‘south’ on SR766.

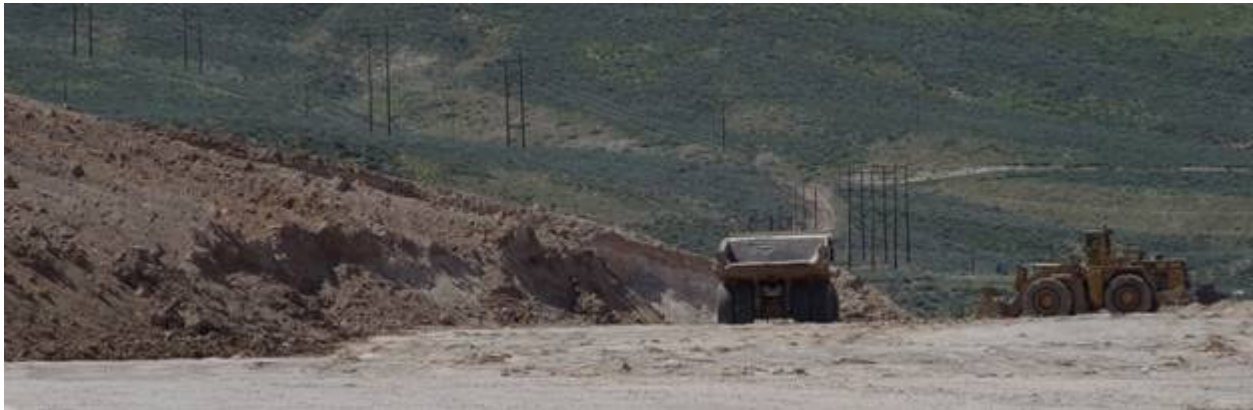
**Figure 7.** Road excavation in progress.

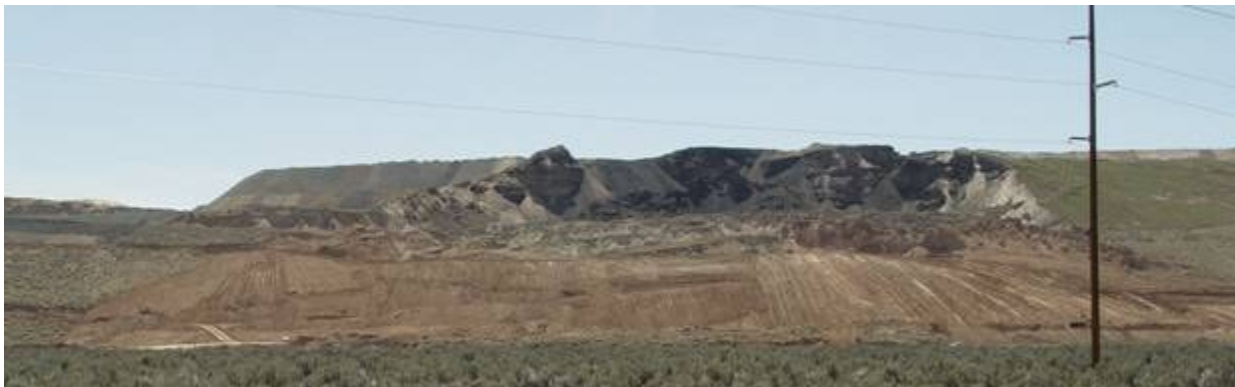
**Figure 8.** View of face of slide area showing unweighting cut (upper bench), slide ‘shaping’, and road excavation.
